# **INVESTIGATION REPORT**

## *Recycling Plant Laborer Engulfed by a Load of Plastics on a Conveyor in New Jersey*

**New Jersey FACE 99-NJ-024**

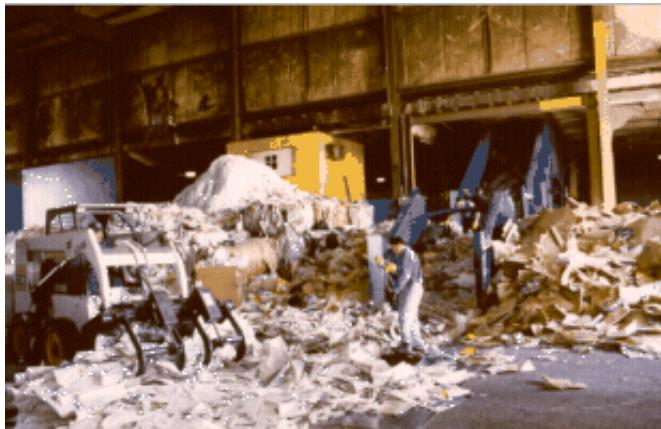
Loading Area of Conveyor

The hinged steel belt conveyor belt that fed the baler was 70 inches wide, 63 feet long, and surrounded by a smooth, stainless steel perimeter with a 3° grade at the beginning of the conveyor. Its speed was measured at approximately 2 feet 3 inches per 5 seconds (27 feet per minute). The flat section of the conveyor was 15 feet long. At 15 feet, the conveyor made its first angle upward and was protected by a steel skirt on each side. Here an 18 inch circumference cross piece was welded across the skirt. A second cross piece was welded in place about 10 feet from the first. The first had been added to the conveyor system by the company to prevent materials from falling back as the conveyor inclined. The second cross piece was installed for workers to hold on to as they worked on the slowly moving conveyor.

Employees started work at 7 a.m. and worked through the morning. Around 12:30 p.m., workers were reprocessing 500 pound plastic bales into bales with sizes appropriate for overseas shipping. It was about 44° F. in the warehouse. The skid steer loader had dropped bales of plastics near the base of the conveyor. Workers were pushing the mounds of materials onto the conveyor belt. The victim stood near the conveyor, apparently on the smooth, steel perimeter. He may have been removing the strapping that was mixed with the plastics and may have slipped on the plastics. The victim fell onto the moving conveyor belt and was driven along feet first amidst the materials to the section of the belt where it began its elevation.

The victim was lying on the conveyor in a pile of several feet of heavy, compressed plastics and other materials, wedged between the conveyor and materials. His lower right leg and foot were tightly entangled in plastic materials.

Workers called for help. Although there was an emergency stop button on the conveyor, 10 feet from the floor, it was not functioning. The conveyor was stopped by the baler operator after workers ran to the operator's cab to tell him what happened. He was unable to observe the incident from inside the operator's cab. The workers and the plant manager unsuccessfully tried to remove the victim from the compacted materials that were on top of him. They cut away the first of the cross pieces to release the load of plastics.

The employer has repaired the shut off device. It is suggested that an emergency stop cord also be installed along the length of the top of the conveyor side frame. A worker on the moving conveyor would be able to pull the cord to stop the movement of the belt.
